# City of Elkins

## Asbestos Inspection Report

129 DIAMOND STREET

Date of Inspection: 08/13/2025

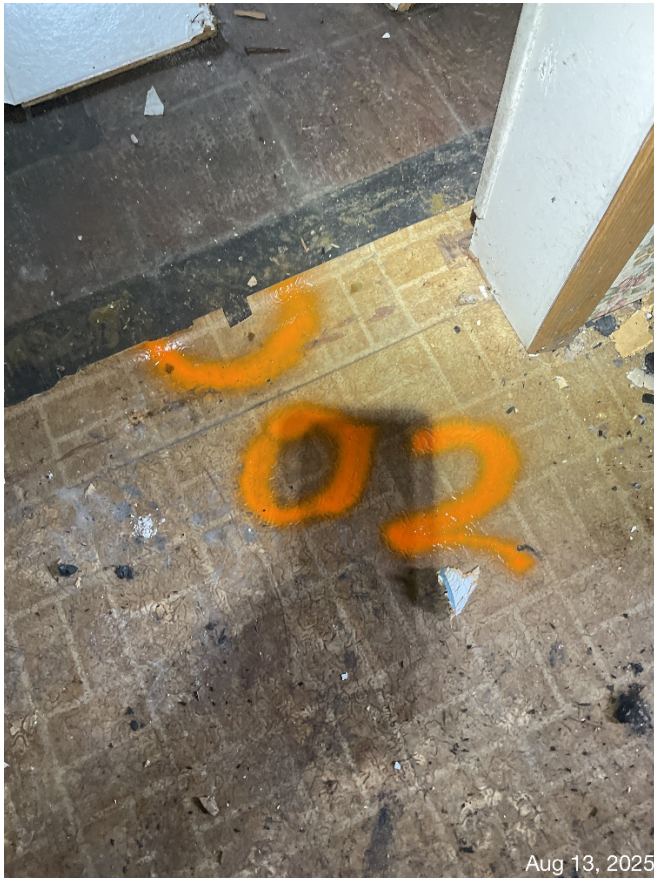
Sample 02

| Client ID | Lab | Lab | NON-ASBESTOS COMPONENTS | | | | ASBESTOS |
|---|---|---|---|---|---|---|---|
| 02<br>3650211 | Sheet Vinyl | Heterogeneous<br>Tan<br>Fibrous<br>Bound | 30% | Cellulose | 50% | Vinyl | Chrysotile 20% |
| 02 (2)<br>3660876 | Mastic | Homogeneous<br>Black<br>Non-Fibrous<br>Bound | | | 98% | Tar | Chrysotile 2% |

| Client Sample ID | Sample Note | Quantity | Sampler(s) |
|---|---|---|---|
| 02 | tan linoleum | | |

| <b>Client Sample ID</b> | <b>Sample Location</b> |
|---|---|
| 02 | kitchen |

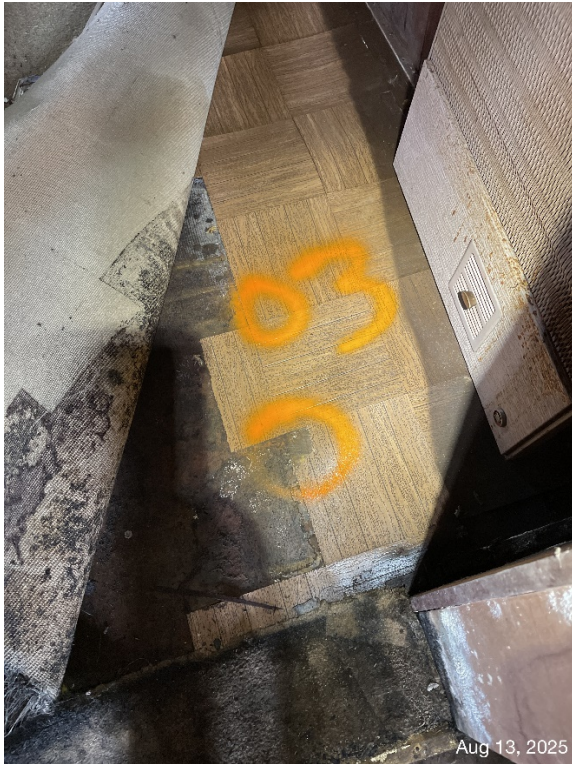
Sample 03

| Client ID | Lab | Lab | NON-ASBESTOS COMPONENTS | | | | ASBESTOS |
|---|---|---|---|---|---|---|---|
| 03<br>3650212 | Floor Tile | Heterogeneous<br>Brown<br>Non-Fibrous<br>Bound | | | 92% | Vinyl | Chrysotile 8% |
| 03 (2)<br>3660910 | Mastic | Homogeneous<br>Clear<br>Non-Fibrous<br>Bound | | | 100% | Mastic | Chrysotile <1% |

| Client Sample ID | Sample Note | Quantity | Sampler(s) |
|---|---|---|---|
| 03 | 9x9 wood look tiles | | |

| <b>Client Sample ID</b> | <b>Sample Location</b> |
|---|---|
| 03 | living room |

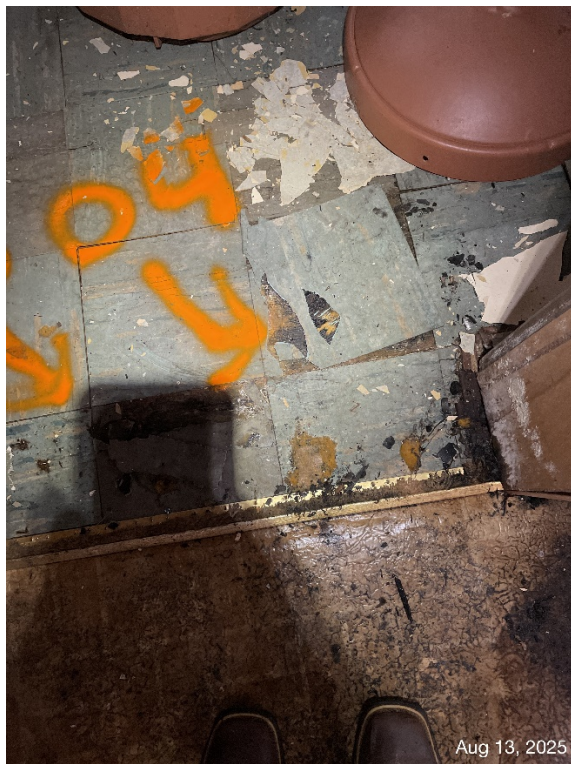
Sample 04

| Client ID | Lab | Lab | NON-ASBESTOS COMPONENTS | | | | ASBESTOS |
|---|---|---|---|---|---|---|---|
| 04<br>3650213 | Floor Tile | Homogeneous<br>Blue/green<br>Non-Fibrous<br>Bound | | | 92% | Vinyl | Chrysotile 8% |
| 04 (2)<br>3661079 | Mastic | Homogeneous<br>Black<br>Non-Fibrous<br>Bound | | | 98% | Tar | Chrysotile 2% |

| Client Sample ID | Sample Note | Quantity | Sampler(s) |
|---|---|---|---|
| 04 | 9x9 teal tiles | | |

| <b>Client Sample ID</b> | <b>Sample Location</b> |
|---|---|
| 04 | dining room |

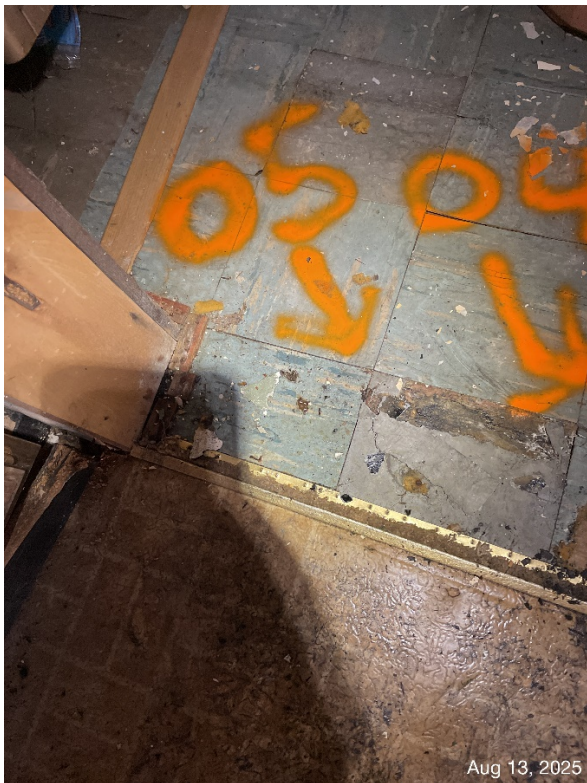
Sample 5

| Client ID<br>Lab ID | Lab<br>Description | Lab<br>Attributes | NON-ASBESTOS COMPONENTS | | | | ASBESTOS<br>% |
|--|---|--|---|---|---|--|---|
| 05<br>3650214 | Floor Tile | Homogeneous<br>Gray<br>Non-Fibrous<br>Bound | | | 93%<br>Vinyl | | Chrysotile 7% |
| 05 (2)<br>3661108 | Mastic | Homogeneous<br>Black<br>Non-Fibrous<br>Bound | | | 98%<br>Tar | | Chrysotile 2% |

| Client Sample ID | Sample Note | Quantity | Sampler(s) |
|---|---|---|---|
| 05 | 9x9 grey tiles | | |

| <b>Client Sample ID</b> | <b>Sample Location</b> |
|---|---|
| 05 | dining room |

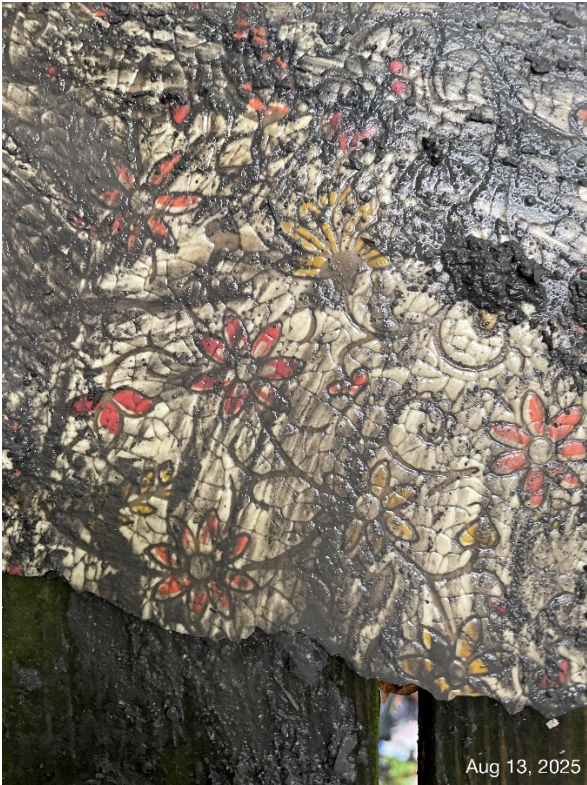
## Sample 09

| Client ID<br>Lab ID | Lab<br>Description | Lab<br>Attributes | NON-ASBESTOS COMPONENTS | | | | ASBESTOS<br>% |
|--|---|--|---|---|---|--|---|
| 09<br>3650218 | Sheet Vinyl | Homogeneous<br>Multi-colored<br>Fibrous<br>Bound | 30% | Cellulose | 50%<br>Vinyl | | Chrysotile 20% |

| Client ID | Lab | Lab | NON-ASBESTOS COMPONENTS | | ASBESTOS |
|---|---|---|---|---|---|
| 09 (2) | Mastic | Homogeneous | 98% | Mastic | Chrysotile 2% |

Analyst opinion: Possible contamination from adjacent positive sheet vinyl.

| Client Sample ID | Sample Note | Quantity | Sampler(s) |
|---|---|---|---|
| 09 | flowered linoleum | | |

| <b>Client Sample ID</b> | <b>Sample Location</b> |
|---|---|
| 09 | second floor bathroom |
